Manhole Inspection Summary

Manhole # S45GG_062MH

Insp Date: **2/17/10 11:59 AM**

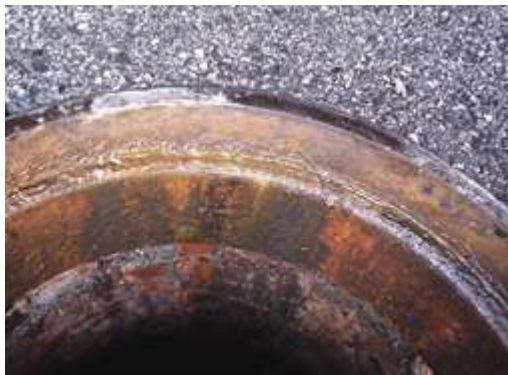
Defect 1

frame leaks

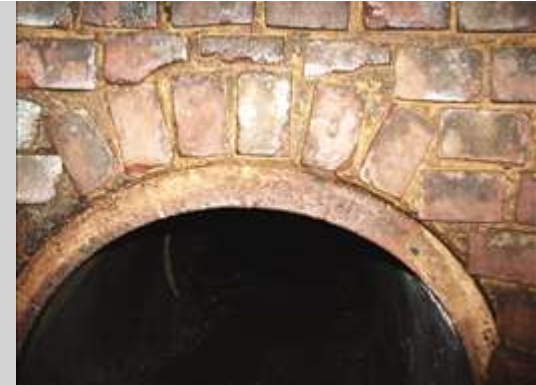
21 in. Circular Gravity Sewer
Pipe Out @ 12 O'Clock

Pipe Height: **21.6** (in.) Rod and Bar (Angled)
Pipe Material: **Clay** ☐ Pipe Lined
Invert Depth: **12.50** (ft.) Flow Characteristics: **Slow**
Deposits: ☒ None ☐ Mud ☐ Sludge ☐ Debris ☐ Grease
Silt Depth: (in.) Deposits Extent:
Infiltration: **None** Pipe Seal Cond: **Sound**

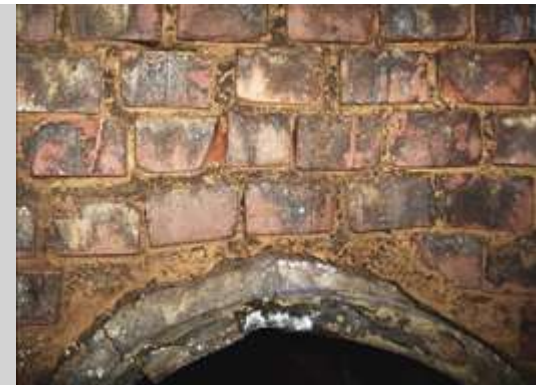
21 in. Circular Gravity Sewer
Pipe In @ 6 O'Clock

Pipe Height: **21.6** (in.) Rod and Bar (Angled)
Pipe Material: **Clay** ☐ Pipe Lined
Invert Depth: **12.42** (ft.) Flow Characteristics: **Slow**
Deposits: ☒ None ☐ Mud ☐ Sludge ☐ Debris ☐ Grease
Silt Depth: (in.) Deposits Extent:
Infiltration: **None** Pipe Seal Cond: **Cracked**

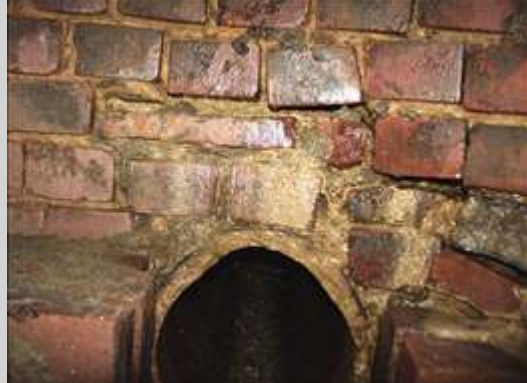
Pipe In @ 9 O'Clock

Pipe Height: **8.4** (in.) Rod and Bar (Angled)

Infiltration: **None** Pipe Seal Cond: **Sound**
